**Genesee County
Phase II Municipalities**

**Annual Report
Nov. 1, 2006 to Oct. 31, 2007**

**State of Michigan Department of Environmental Quality
Surface Water Quality Division**

**Genesee County Drain Commissioner
October 2007**

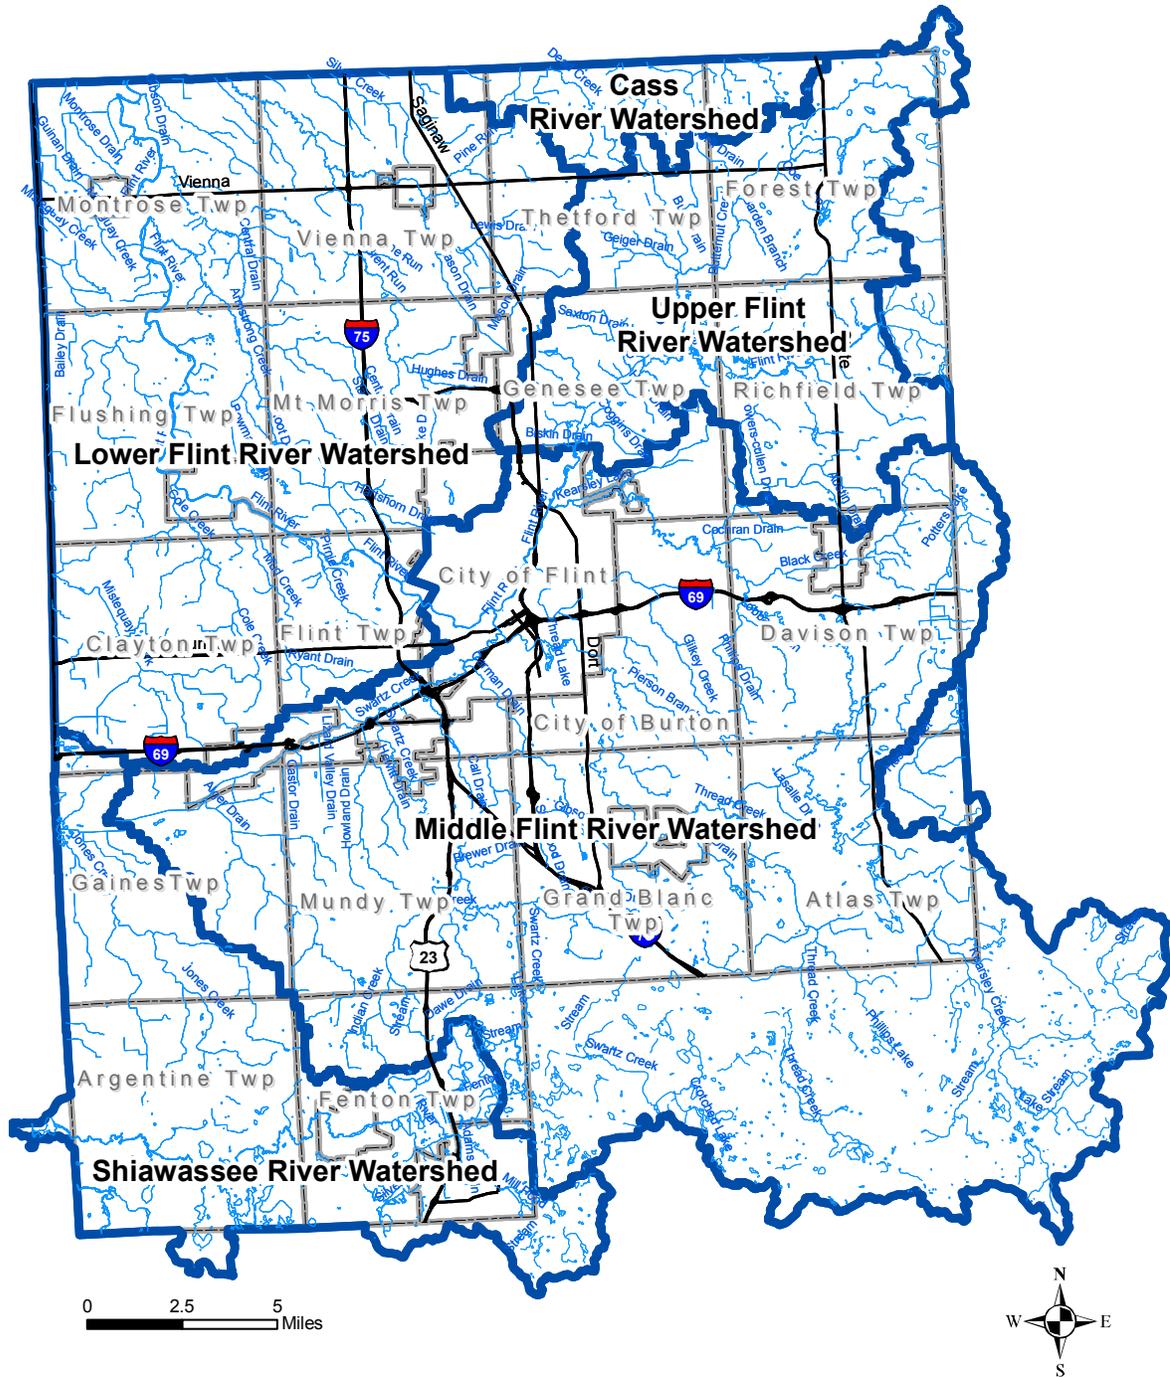
Figure 1-1 Genesee County Watershed Boundaries

Figure 1-1 shows the watershed boundaries. The Shiawassee River Watershed boundary was adjusted in 2005 to minimize overlap with effort proceeding in Livingston County. Tributary areas previously studied as part of the Upper II Shiawassee by Livingston County and outlets into the main channel within Genesee were cut off at the county line. The five major watersheds listed above were divided into 20 sub-watershed planning areas.

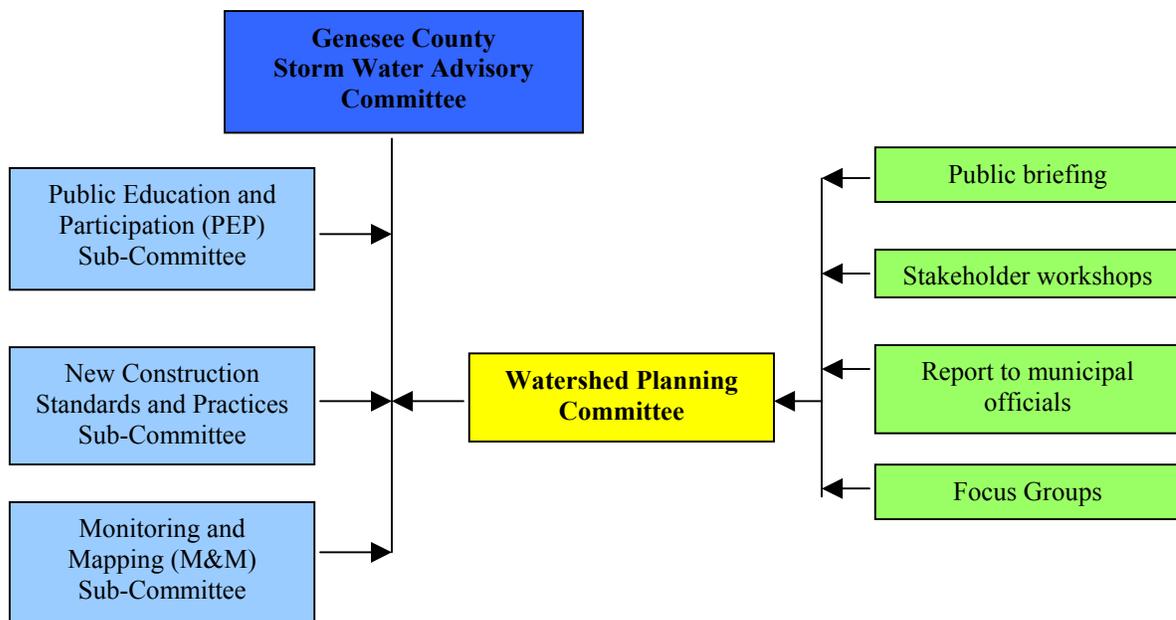
Figure 1-2 Watershed Planning Decision Making Flowchart

Figure 1 shows the watershed planning decision-making process and sub-committee relationships. A brief description of sub-committees duties is presented below. Work conducted by the Watershed Planning Committee(s) is used in development of the Lower Flint, Middle Flint, and Shiawassee River Watershed Management Plans (WMPs). The Watershed Planning Committee(s) are made up of those communities that are located within a specific watershed. The 3 above sub-committees implement the watershed plan, education plan & IDEP plan. Each community serves on at least one sub-committee.

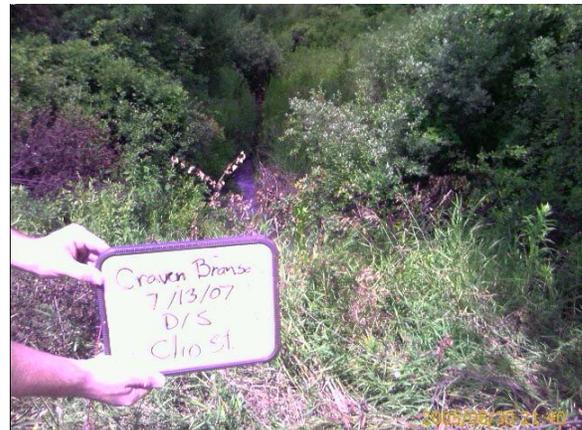
Figure 5-1 Road Stream Crossing Locations

During summer of 2007, a team of Tetra Tech field staff conducted a visual assessment along the Lower Flint River and small tributaries. The crews investigated 40 road-stream crossings along the Flint River and waterbodies tributary to the Flint River in Genesee County. Survey locations are presented in Figure 5-1. The river assessment identified the bottom substrate, type of bank vegetation, surrounding land use and potential pollution sources. Road-stream inventories were completed at approximately 11 percent (40 out of 350) of the crossings in the sub-watershed. Of the total 350 road stream crossing located in the Lower Flint River sub-watershed, approximately 50 percent are located within the urbanized areas.

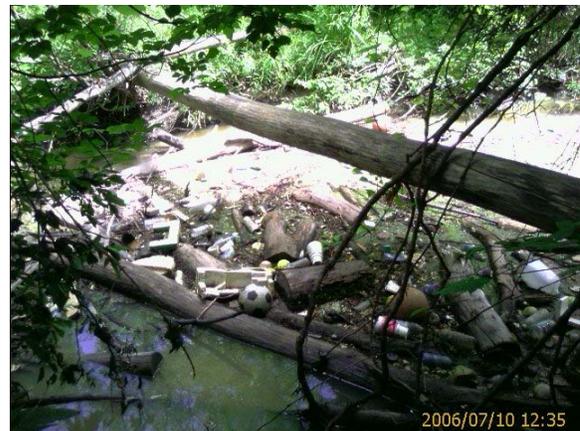
Figure 5-4 Improve Recreation, Trash Clean Up and IDEP Issues

If a stream channel was observed to be wider than 25 feet, deeper than 3 feet, and woody debris and logs were present, the site was identified as a problem. The analysis identified 11 sites for areas to improve canoeing and recreation. The locations are presented in Figure 5-4.

Tetra Tech crews were able to identify whether trash was not present, present, or abundant. Reaches requiring cleaning were assumed to include any reaches with trash present or in abundance. Trash observations were noted at 11 of the sites investigated. Figure 5-4 identifies the location of all of the trash cleanup sites.

Seventeen locations were identified as having potential illicit discharge problems. These locations are presented in Figure 5-4.

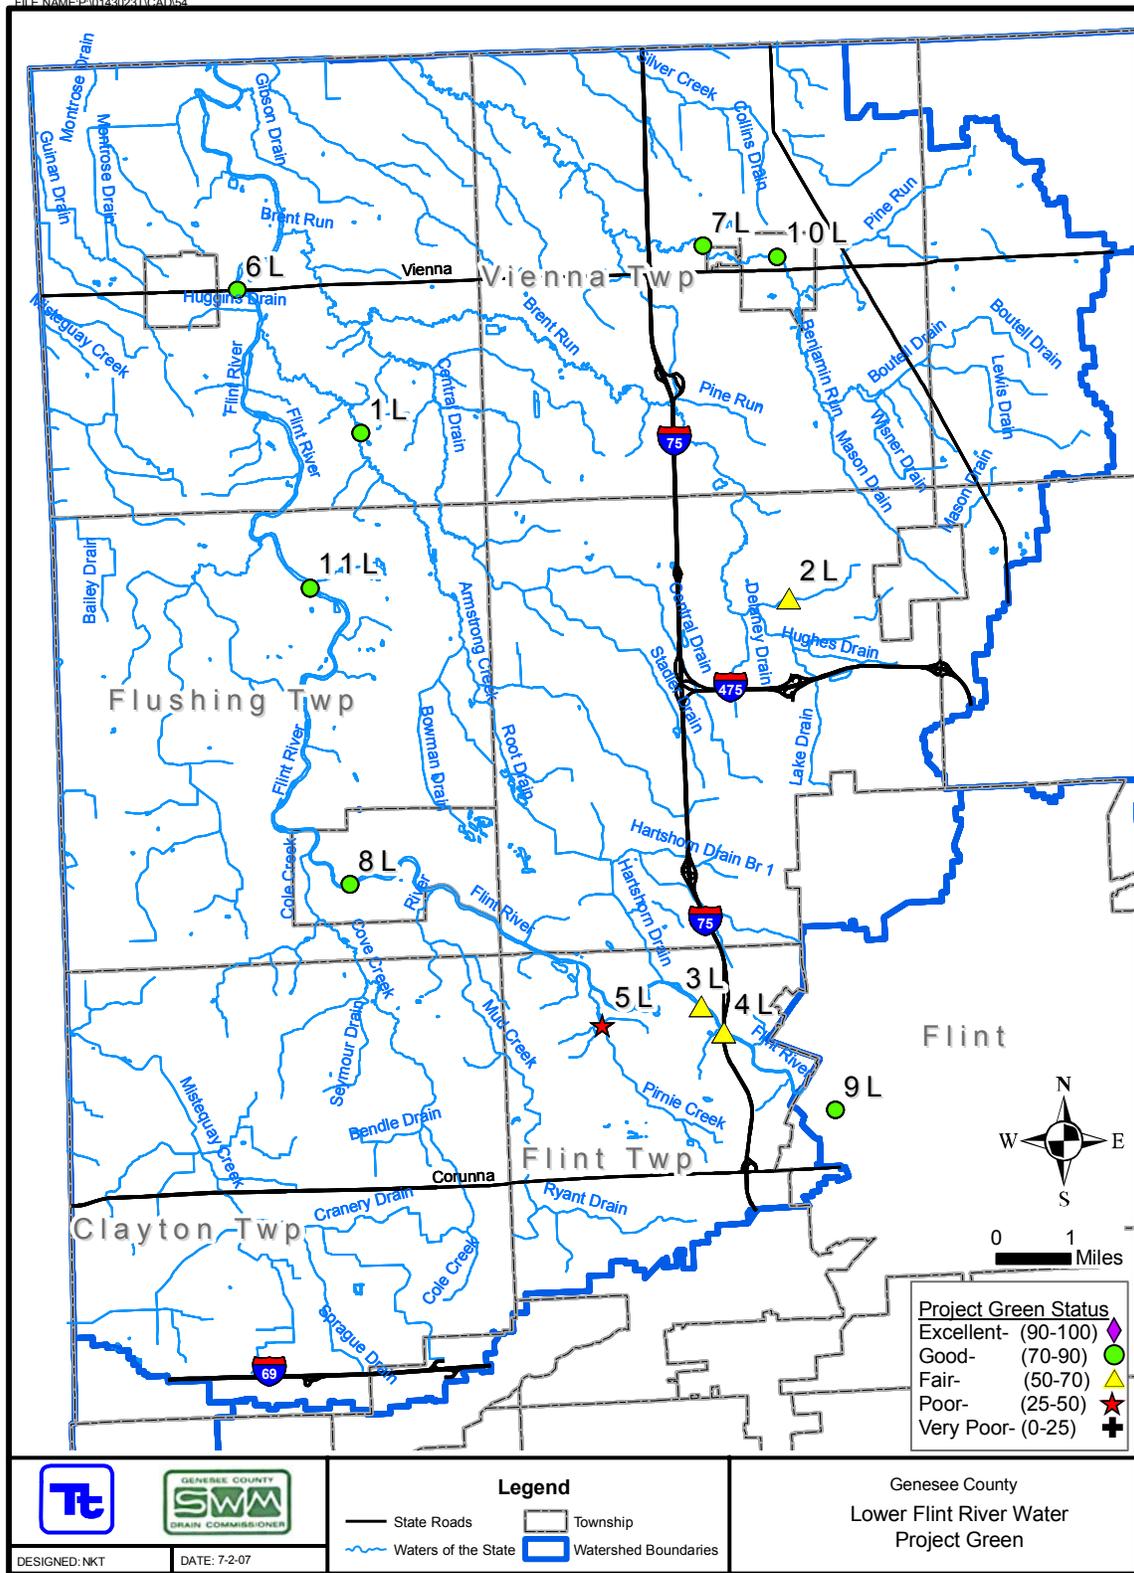
Figure 7-1 Project GREEN Results for the Lower Flint River Watershed

Each site visited is categorized as excellent, good, fair (medium), poor (bad), or very poor (very bad) based on the National Sanitation Foundation (NSF) Water Quality Index (WQI). To determine the WQI, nine tests are performed. Parameters tested include dissolved oxygen, fecal coliform, pH, biochemical oxygen demand (5-day), temperature, total phosphate, nitrates, turbidity, and total solids. After completing the nine tests, results are recorded and transferred to a weighting curve chart where a numerical value is obtained as shown in Table 7-1. For each test, the numerical value or Q-value between 0 and 10 is multiplied by a "weighting factor." For example, dissolved oxygen has a relatively high weighting factor (0.17) and therefore is more significant in determining water quality than the other tests. The nine resulting values are then added together to arrive at an overall water quality index (WQI). If all nine water quality tests are not available then multiply the total of those samples available by the inverse their total weighting factors.

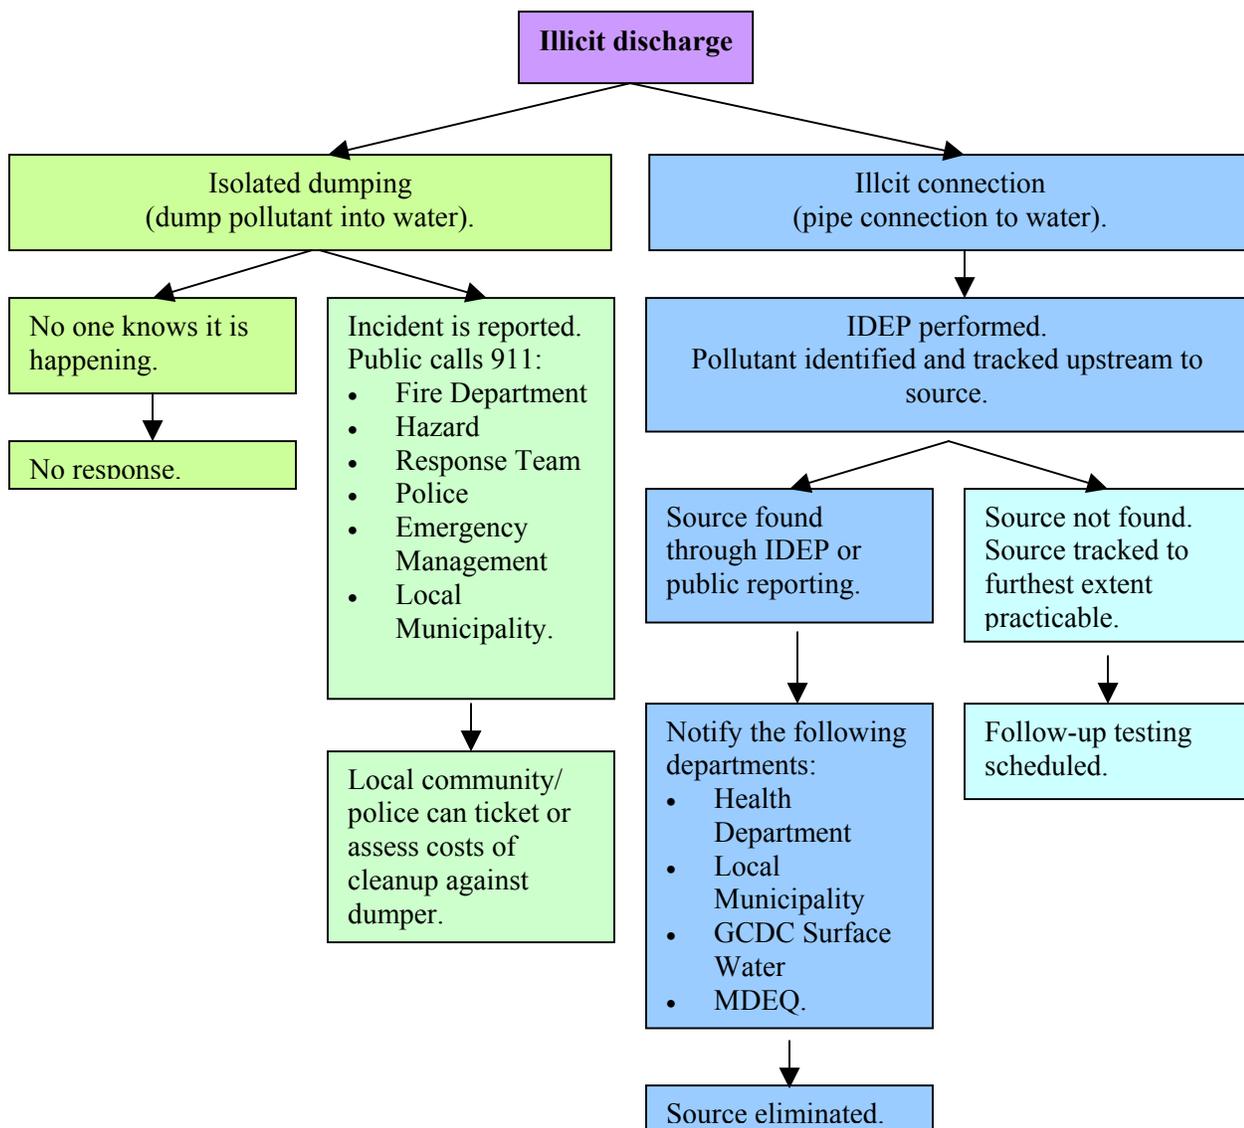
Figure 9-1 Illicit Discharge Notification System Process

To date, Genesee County has focused on completing Dry Weather Flow investigations within Phase II communities urbanized areas, (excluding the City of Flint) and some laterals, especially along I-75 and I-69. A total of 25 hot spots have been found and Tetra Tech conducted follow up investigations. All of the IDEP information has been entered into a web base database and PSD points are plotted on a GIS map. When the mapping is complete for the entire County, it will be available on the GCDC public website. In addition, the County has added an illicit discharge reporting page on their web-site. The page will give general information about illicit discharges and phone numbers to call when someone finds an illicit discharge.

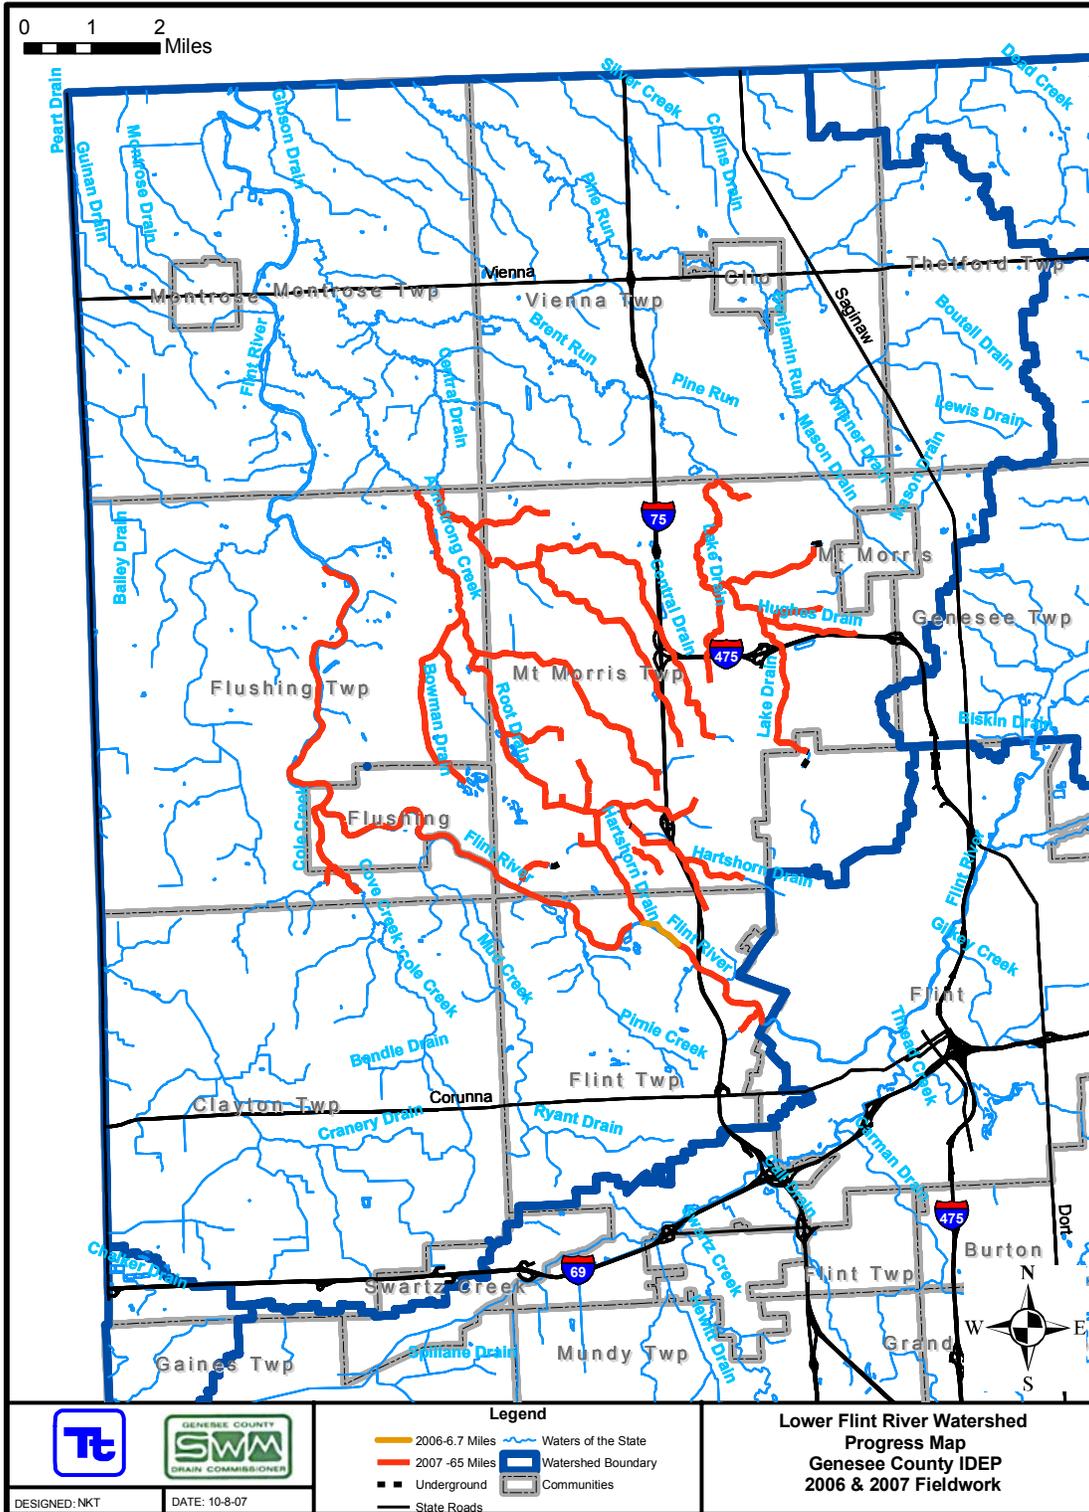
Figure 9-2 Lower Flint River Watershed – IDEP Program Status

In 2006 and 2007, IDEP investigations were conducted in the Lower Flint River Watershed. As shown in Figure 9-2, 72 miles of drain and river were walked or kayaked. Nine illicit connections were found. Table 9-1 provides a description of the illicit connections, corrective actions taken, and current status. All nine illicit connections listed are pending further investigation. The County will dye test suspected properties to confirm and coordinate disconnection. Once an illicit connection is confirmed, Genesee County will notify MDEQ in accordance with its NPDES storm water permit and will proceed to remove the connection. Field crews will continue investigating drains within the Lower Flint River Watershed through the end of 2007 and 2008. Additional illicit connections found will be included in the 2008 Annual Report.

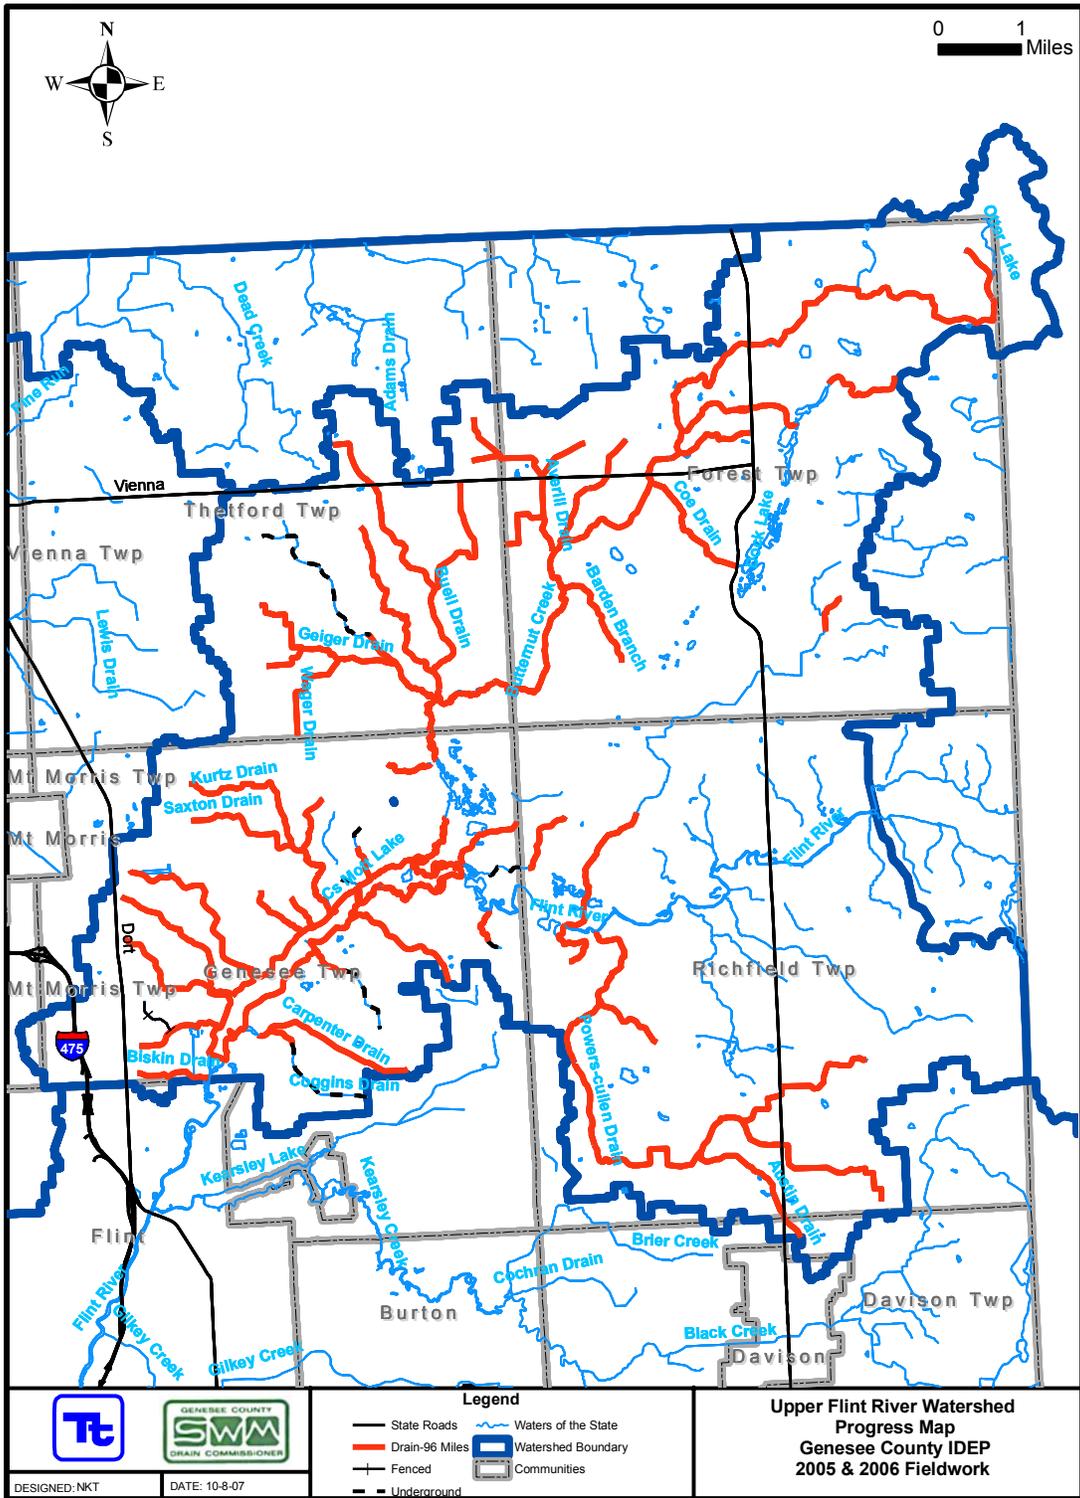
Figure 9-4 Upper Flint River Watershed – IDEP Program Status

In 2006, IDEP investigations were conducted in the Upper Flint River Watershed. As shown in Figure 9-4, field crews walked or kayaked Mott Lake and Butternut Creek and tributary branches. A total of 96 miles of drain were walked. Table 9-5 provides a description of the illicit connections and summarizes corrective actions taken to date and current status. Six illicit connections were identified. Of the six, one has been removed, two were confirmed by dye testing, and three are pending further investigations. The County will dye test the suspected properties to confirm and coordinate disconnection. Once an illicit connection is confirmed, the County will notify MDEQ in accordance with its NPDES storm water permit and begin action to remove the connection. Field crews will continue investigating drains within the Upper Flint River Watershed through the end of 2007 and 2008. Additional illicit connections found will be included in the 2008 Annual Report.

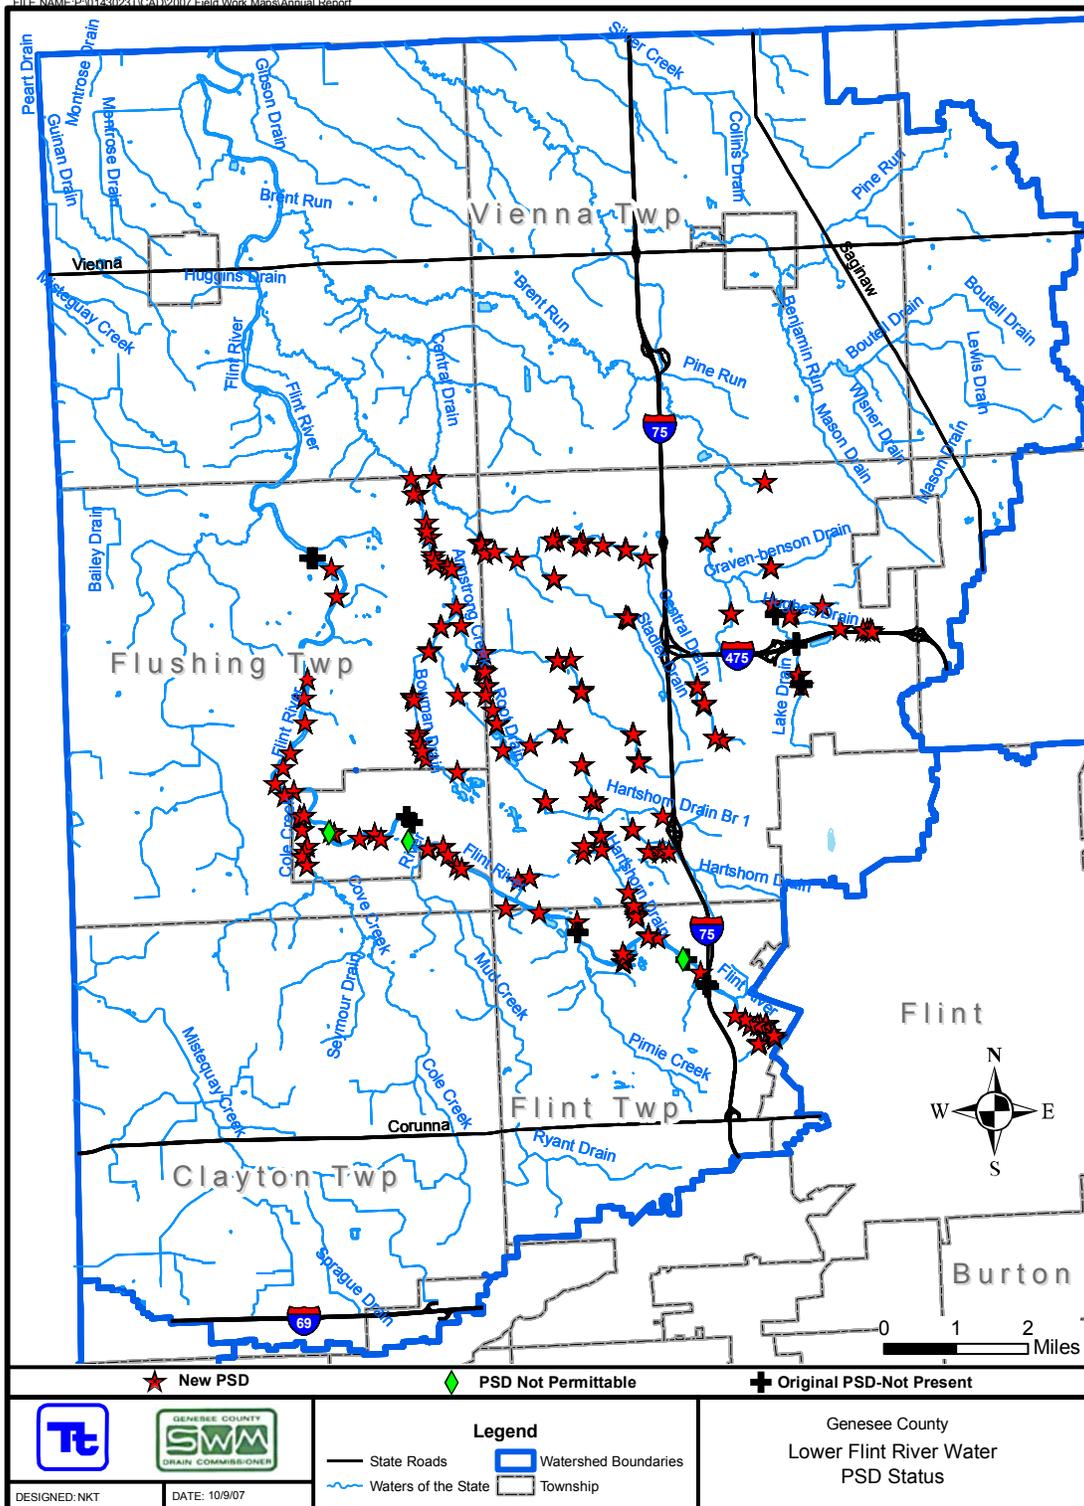
Figure 10-1 Lower Flint River Watershed – “Original PSD Not Present” (16 Total), “PSD Not Permittable” (3 Total) and “New PSDs” (235 Total)

MS4 PSD		Private PSDs		Total
	Identified in 2003 Original Permit as MS4 PSD*	New PSD (Not Identified in 2003 Original Permit)	PSD Not Permittable (Identified in 2003 Original Permit as MS4 PSD)	New PSD (Not Identified in 2003 Original Permit)	
2007 field investigation	55	235	3	257	
Subtotal		290		260	550

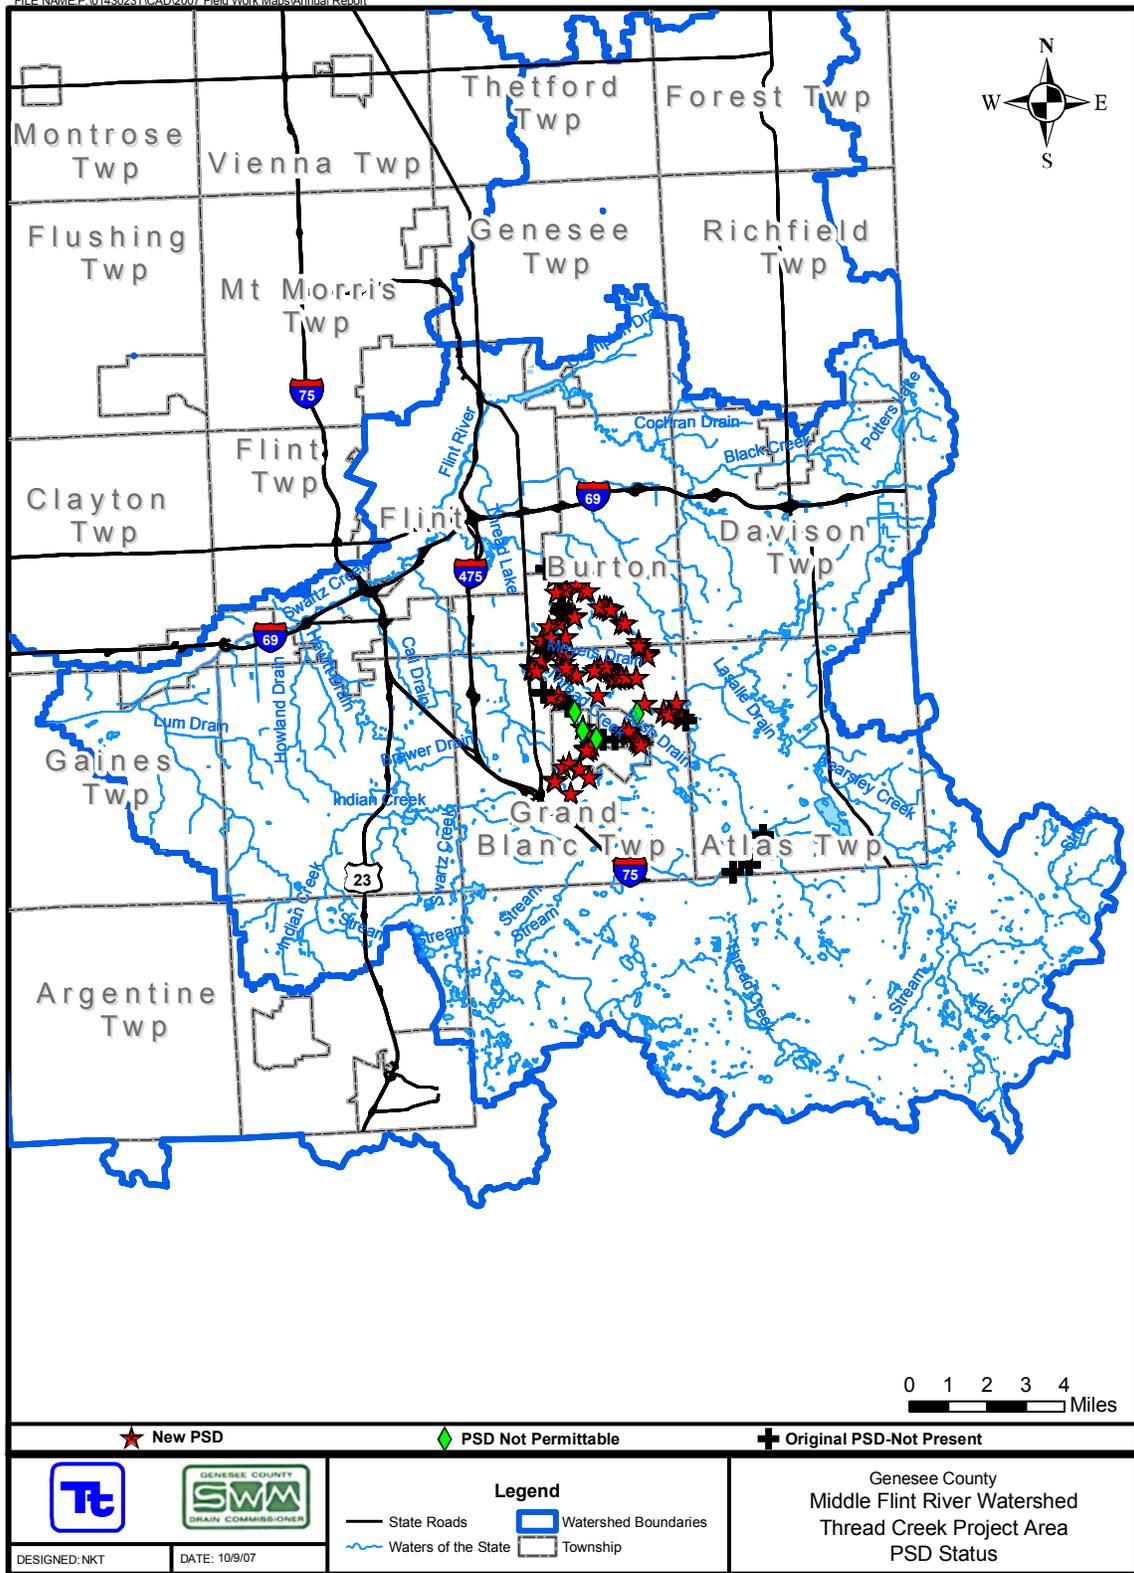
Figure 10-3 Middle Flint River Watershed – Thread Creek - “Original PSD Not

MS4 PSD		Private PSDs		Total
	Identified in 2003 Original Permit as MS4 PSD*	New PSD (Not Identified in 2003 Original Permit)	PSD Not Permissible (Identified in 2003 Original Permit as MS4 PSD)	New PSD (Not Identified in 2003 Original Permit)	
2005-06 field investigation	40	121	4	141	
Subtotal		161		145	306

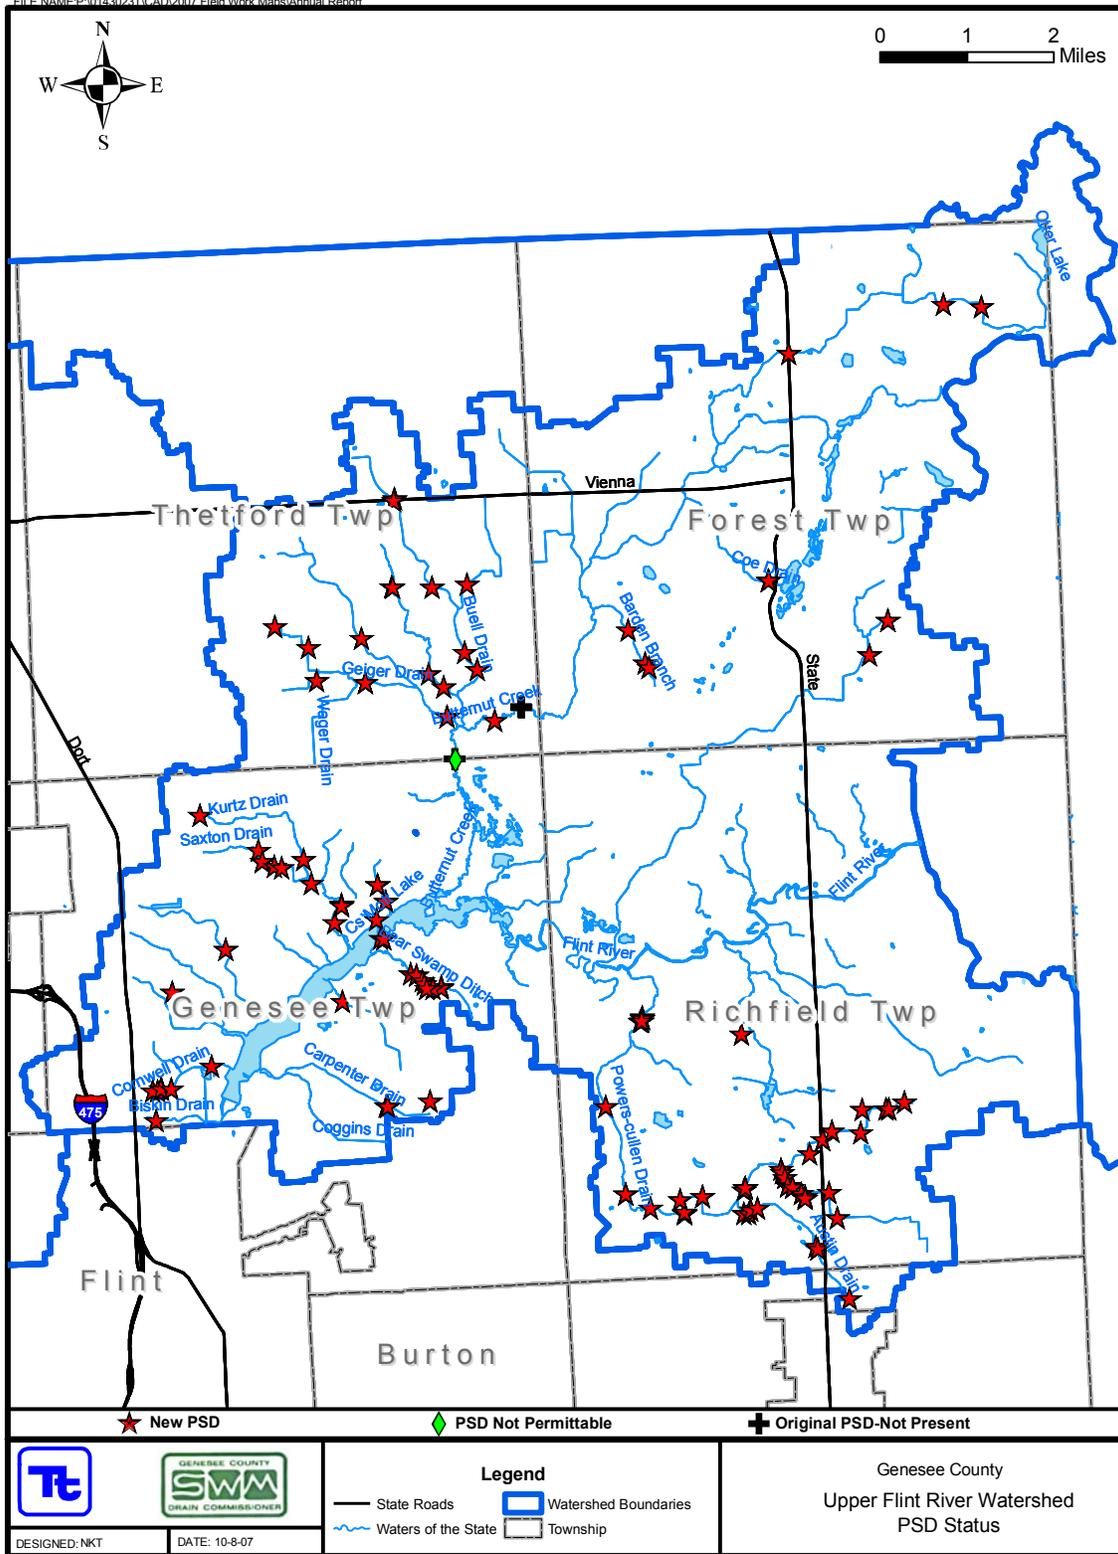
Figure 10-4 Upper Flint River Watershed – “Original PSD Not Present” (4 Total), “PSD Not Permittable” (1 Total) and “New PSDs” (119 Total)

MS4 PSD		Private PSDs		Total
	Identified in 2003 Original Permit as MS4 PSD*	New PSD (Not Identified in 2003 Original Permit)	PSD Not Permissible (Identified in 2003 Original Permit as MS4 PSD)	New PSD (Not Identified in 2003 Original Permit)	
2005-06 field investigation	19	119	1	143	
Subtotal		138		144	282

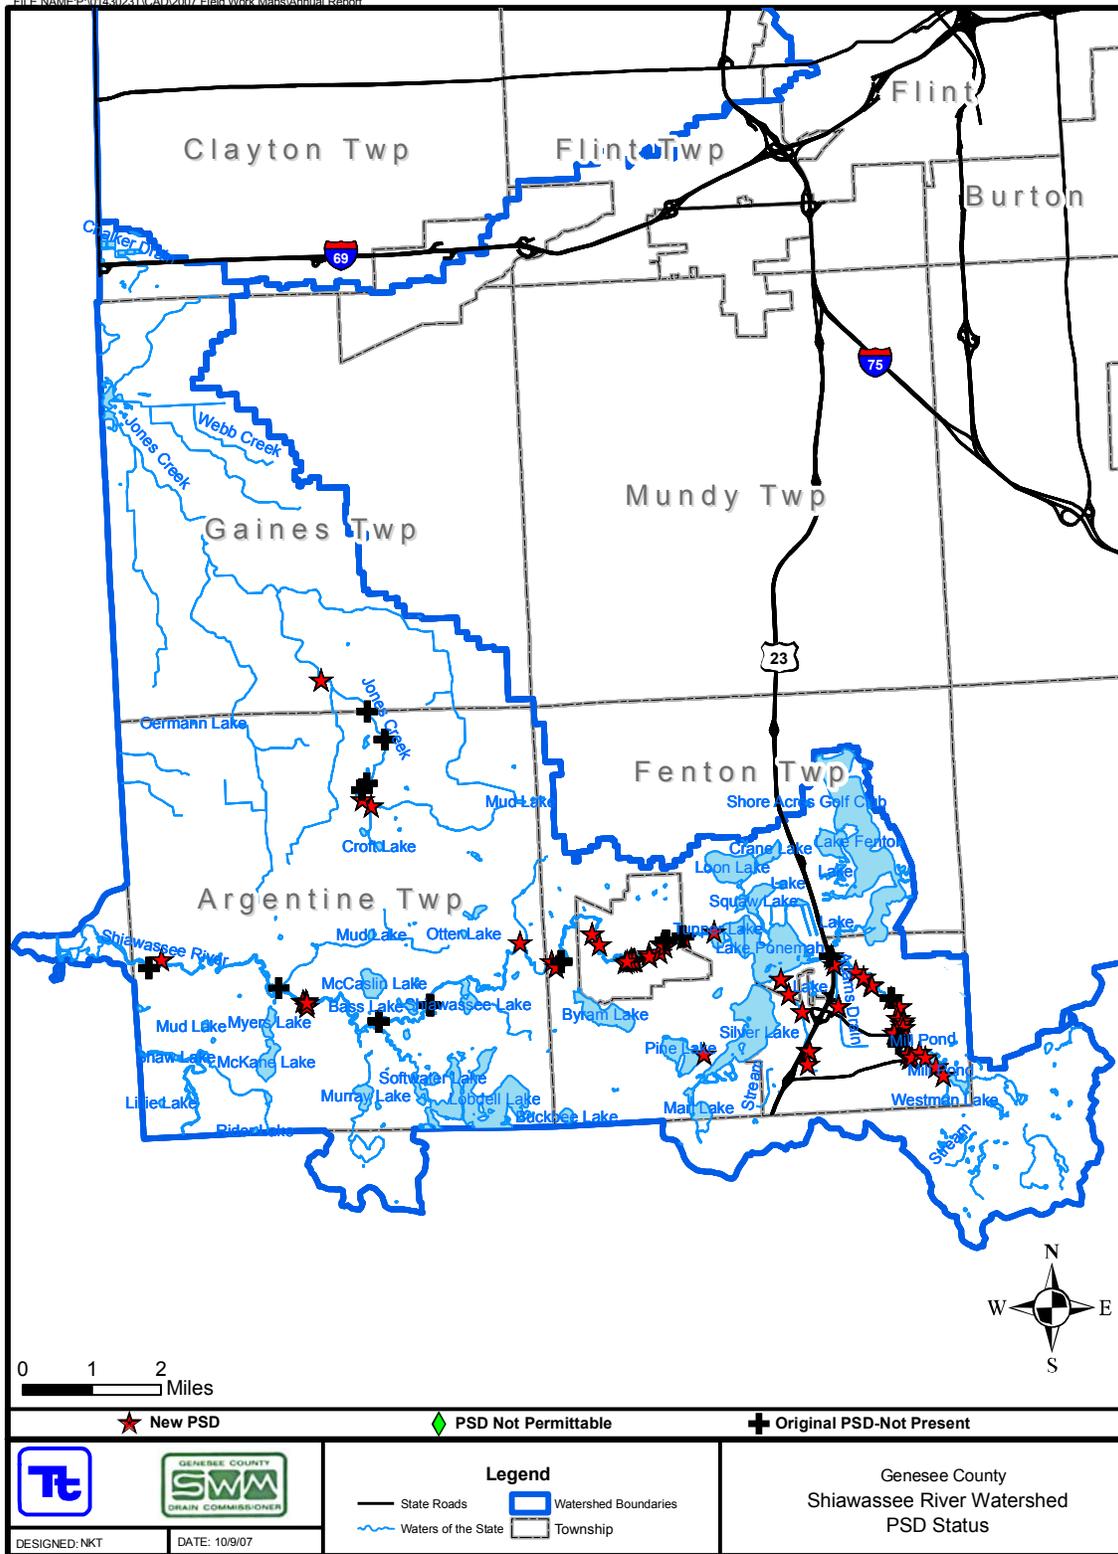
Figure 10-5 Shiawassee River Watershed - “Original PSD Not Present” (37 Total), “PSD Not Permittable” (0 Total) and “New PSDs” (63 Total)

MS4 PSD		Private PSDs		Total
	Identified in 2003 Original Permit as MS4 PSD*	New PSD (Not Identified in 2003 Original Permit)	PSD Not Permissible (Identified in 2003 Original Permit as MS4 PSD)	New PSD (Not Identified in 2003 Original Permit)	
2007 field investigation	37	63	0	75	
Subtotal	100		75		175
